Case Study:

St Marys Primary RC School
Devon Road,
Poole

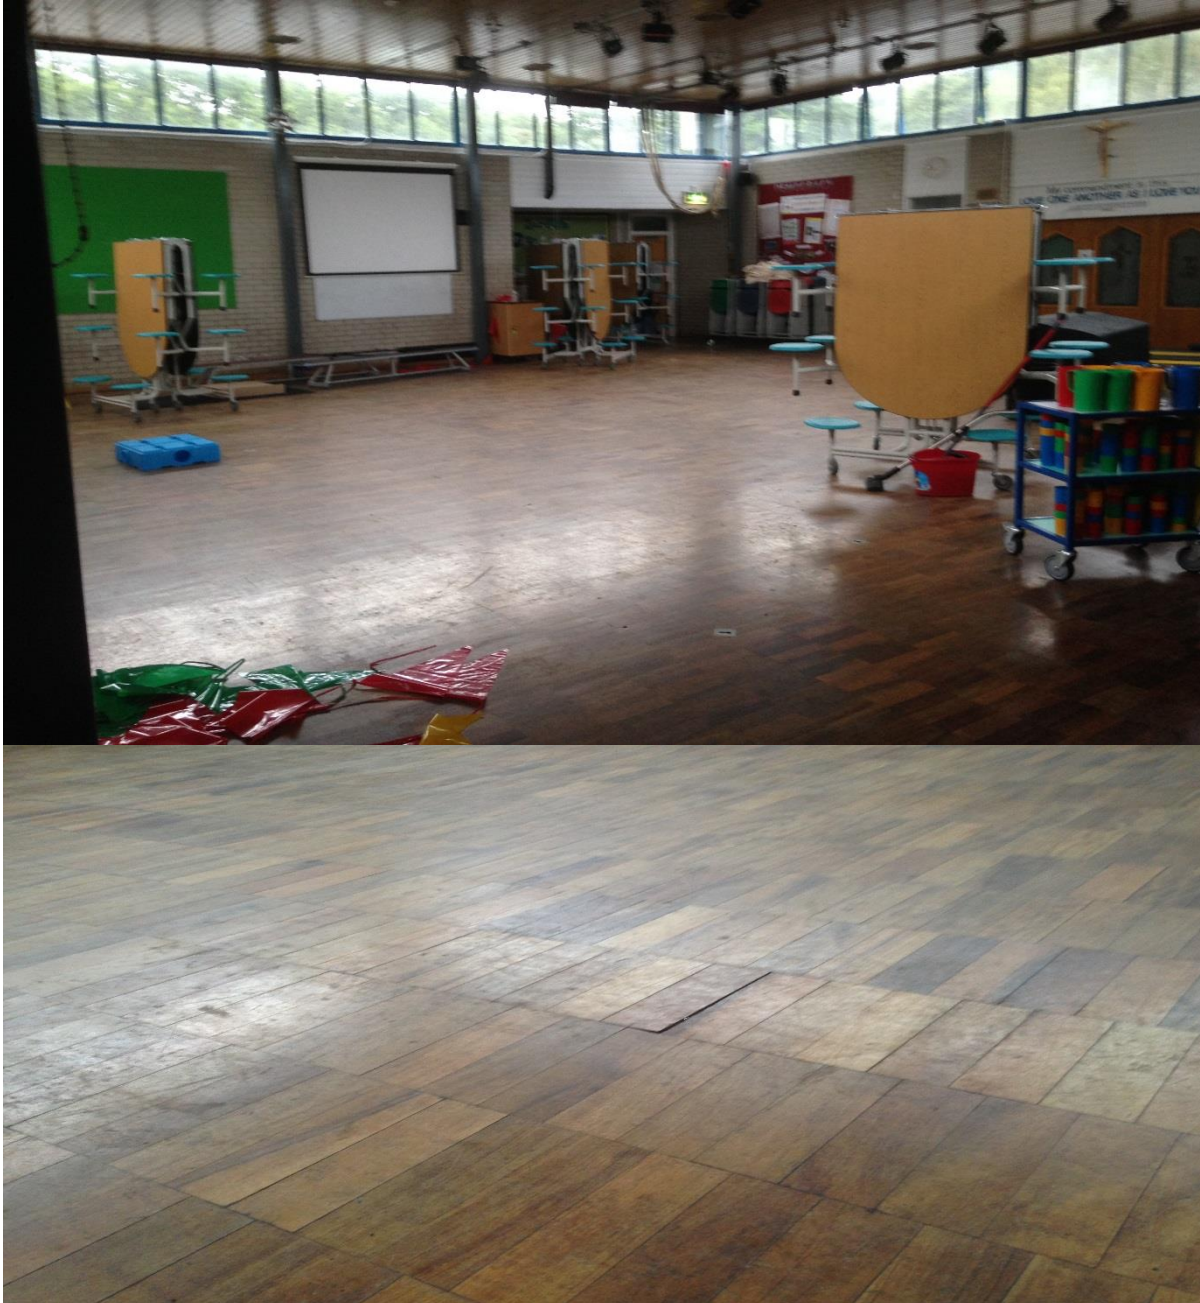
The School Hall

An ingress of water from backed up drains due to heavy rainstorm entered the schools main hall, which was wood parquet block flooring, wetting an area 4.8 metres by 9.10 metres, causing a strip in the centre of the wetted area approximately 4.6 metres by 2.1 metres to buckle upwards by 3 to 4 mm and some cupping to the edges of individual blocks.

The area of floor that had suffered the water ingress gave above acceptable moisture readings with the highest reading of moisture content being the area where the floor was buckling. Thermal imagery was used to understand if there was any surface evaporation taking place, but the results gave no major evidence of endothermic reactions (surface evaporation).

Conclusion: The floor would either have to be totally removed and reinstated or as suggested by R E Spencer Ltd, a thermal energy system could be installed and targeted on the buckled area with air mats positioned on other areas of the floor that were giving high percentage Moisture Content readings.

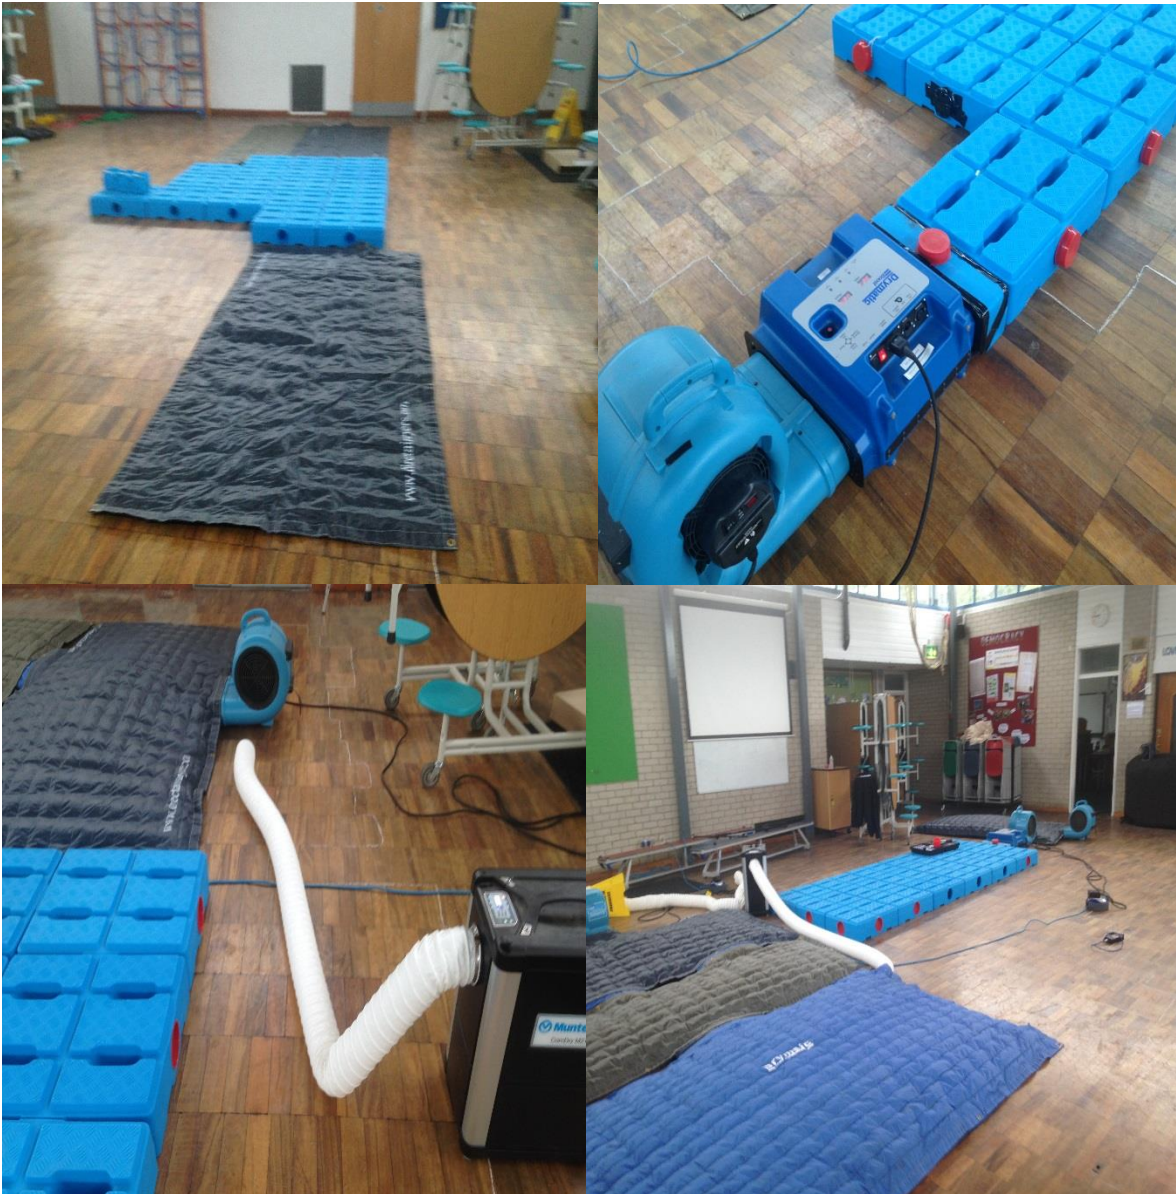
The drying regime was reinspected on 27th August and realigned to achieve maximum coverage over the area that had suffered from the water ingress. Moisture readings were taken of the affected areas including the buckled area that had given the highest reading previously, the moisture content readings were now all reading less than half of the previously recorded data MC reading.

The drying regime that R E Spencer Ltd had decided on for this particular situation was installed on 24th August. A new flat bed thermal drying system was installed on the buckled area of the floor and heat mats were positioned in the areas with the highest percentage of moisture content, dry air from a dessicant dehumidifier was then feed into the air target mats.

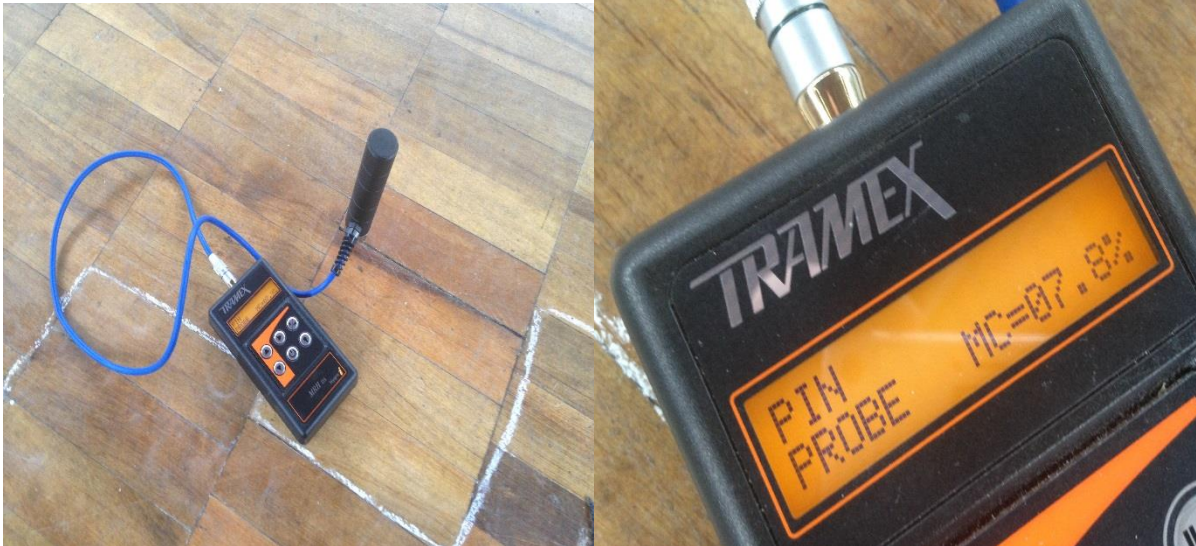
The floor was retested and the results showed that the moisture content readings had reduced considerably, the section of the hall where the main water damage had occurred now showed readings below 8% in comparison to the original readings in this area of 18%. By achieving this level of MC (which is lower than what would be acceptable) it allowed the buckled floor to drop back into position.

The system was switched off on the 31st August and the area left to stabilise for a minimum of 24 hours before further readings were taken.

All that remained was for the wood block parquet floor surface to be sanded down and resealed.
