Case Study:

St Marys Primary RC School
Devon Road,
Poole

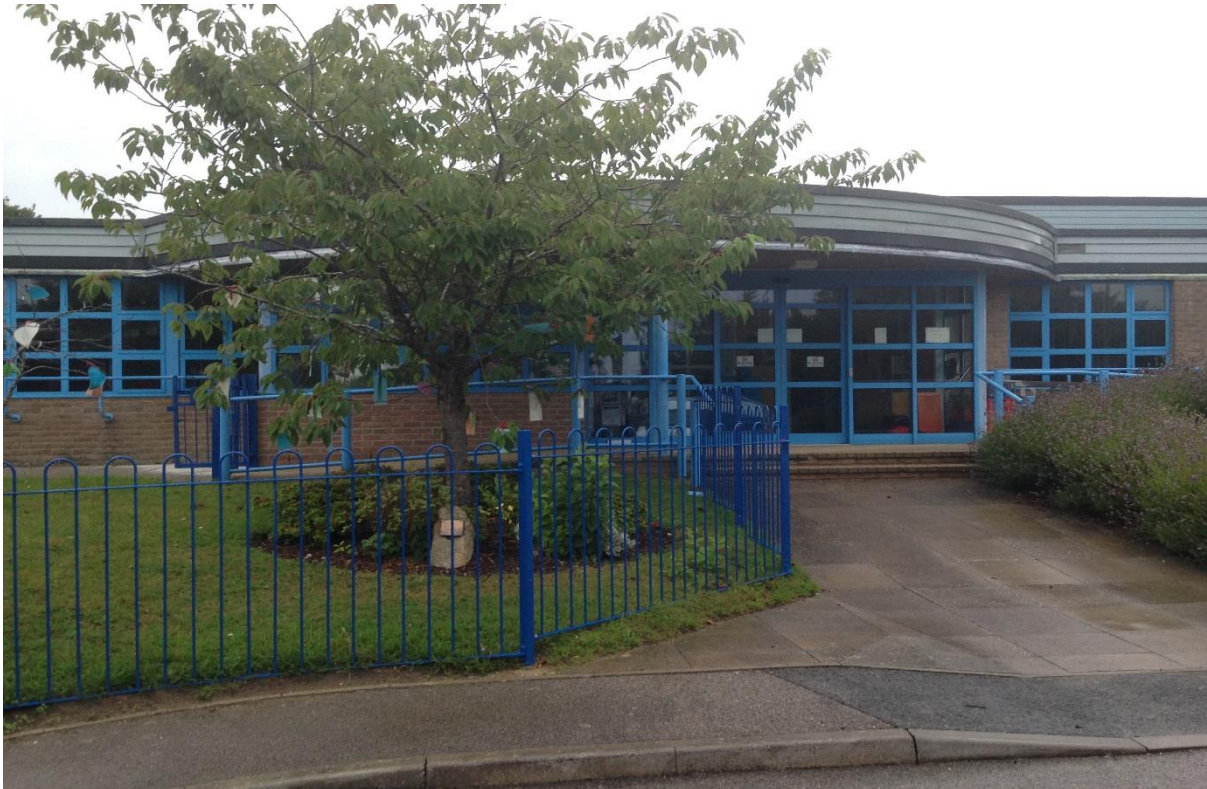
An ingress of water from backed up drains due to heavy rainstorm entered the schools main hall, which was wood parquet block flooring, wetting an area 4.8 metres by 9.10 metres, causing a strip in the centre of the wetted area approximately 4.6 metres by 2.1 metres to buckle upwards by 3 to 4 mm and some cupping to the edges of individual blocks.

The area of floor that had suffered the water ingress gave above acceptable moisture readings with the highest reading of moisture content being the area where the floor was buckling. Thermal imagery was used to understand if there was any surface evaporation taking place, but the results gave no major evidence of endothermic reactions (surface evaporation).

Conclusion: The floor would either have to be totally removed and reinstated or as suggested by R E Spencer Ltd, a thermal energy system could be installed and targeted on the buckled area with air mats positioned on other areas of the floor that were giving high percentage Moisture Content readings.

The drying regime that R E Spencer Ltd had decided on for this particular situation was installed on 24th August. A new flat bed thermal drying system was installed on the buckled area of the floor and heat mats were positioned in the areas with the highest percentage of moisture content, dry air from a dessicant dehumidifier was then feed into the air target mats.
